# *Bravo Home Inspection Service*

## Property Inspection Report

1101 SW 75th AVENUE, Plantation FL, 33317  
Inspection prepared for: & Sample Smith  
Inspection Date: 1/5/2012 Time: 1;00PM  
Age: 1971

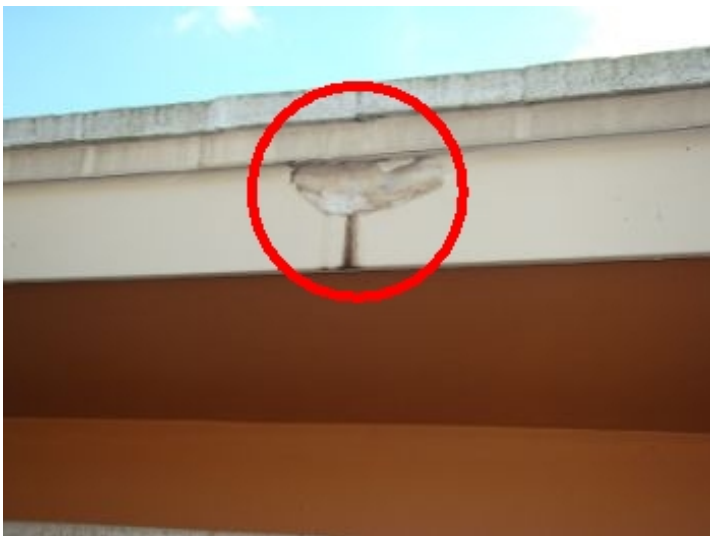
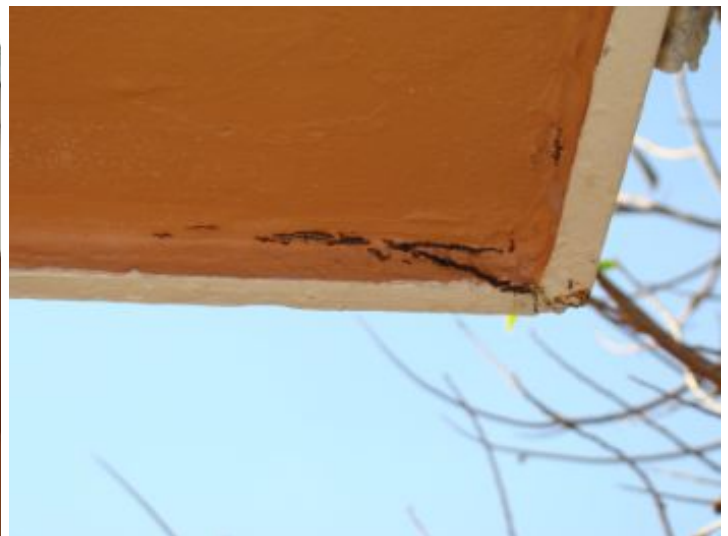
## 3. Eaves & Facia

- Fascia board shows wood decay. Recommended to be repair.

Page 2 Item: 3	Eaves & Facia	• Fascia board shows wood decay. Recommended to be repair.
----------------	---------------	--

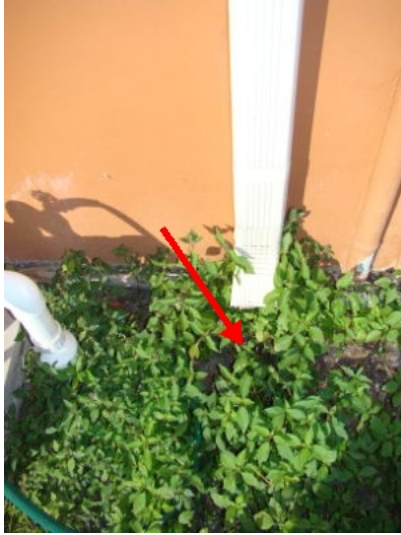
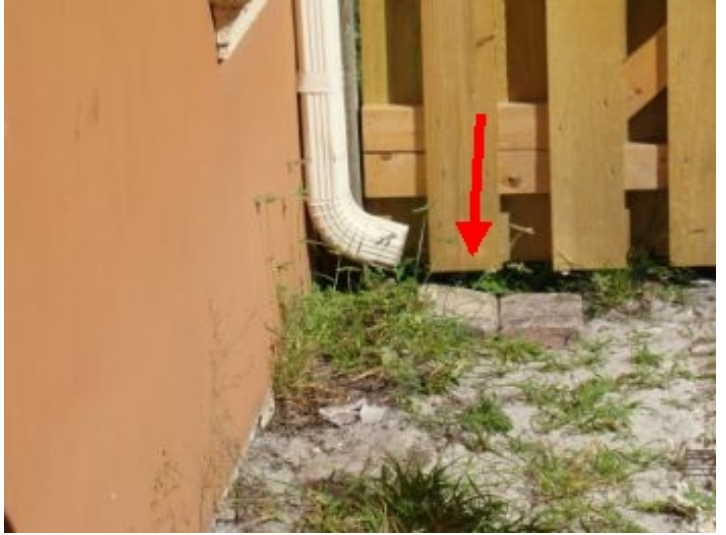
## 2. Gutter & Downspouts

- Extensions / Splash blocks missing or insufficient: Install to divert water away from the foundation.

Page 10 Item: 2	Gutter & Downspouts	• Extensions / Splash blocks missing or insufficient: Install to divert water away from the foundation.
-----------------	---------------------	---

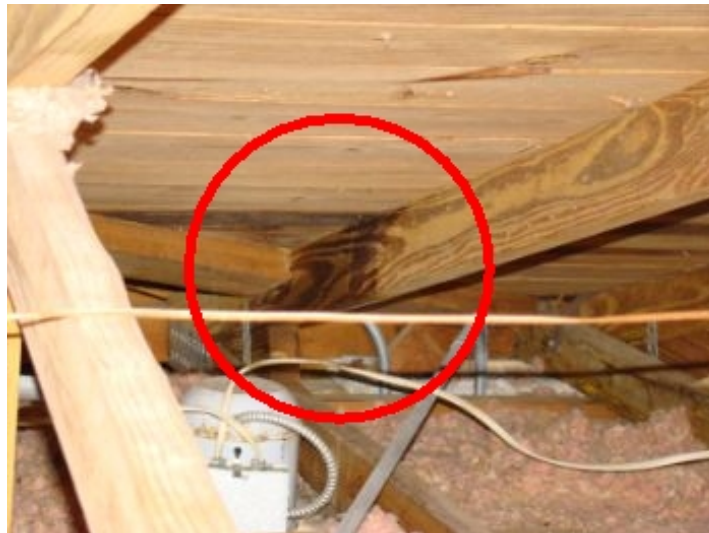
## 2. Structure

Observations:  
 • Evidence of past or present leaks, dry at time of the inspection. Monitor for leaks &/or have roofing contractor evaluate.

Page 11 Item: 2	Structure	• Evidence of past or present leaks, dry at time of the inspection. Monitor for leaks &/or have roofing contractor evaluate.
-----------------	-----------	--

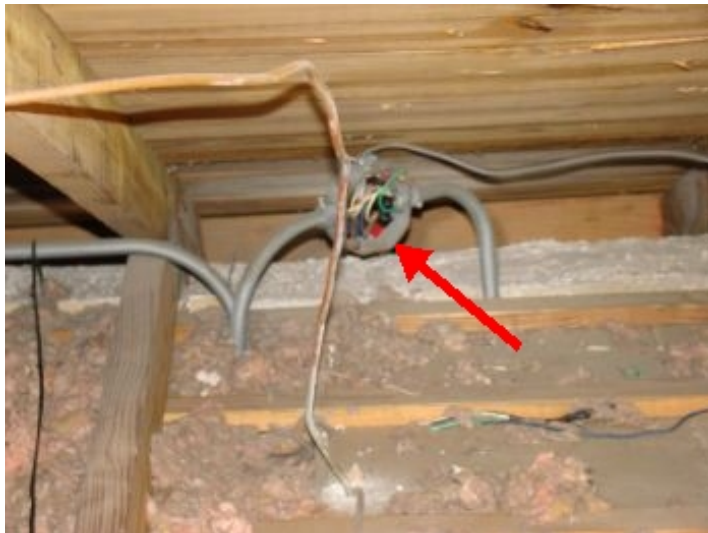
## 5. Electrical

- Open junction boxes were observed, which is a safety concern. Recommend installing proper covers, as needed, for safety.

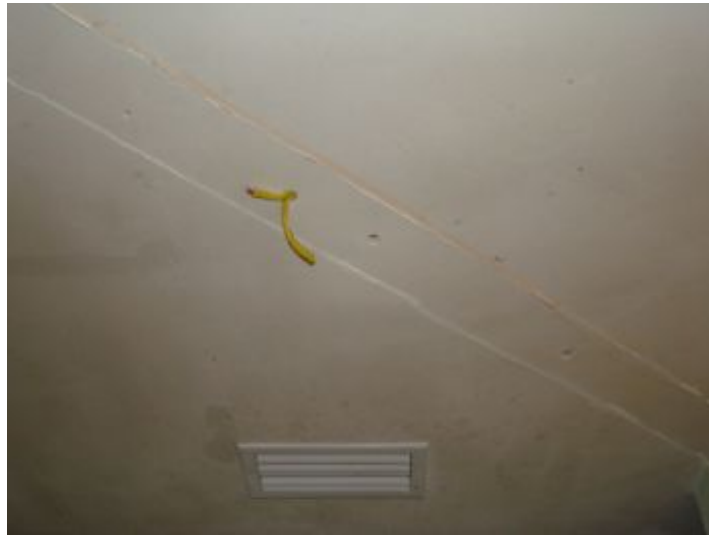
## 4. Electrical

- Have a qualified electrician repair items listed following a complete evaluation of the electrical system.
- Loose hanging wires noted.

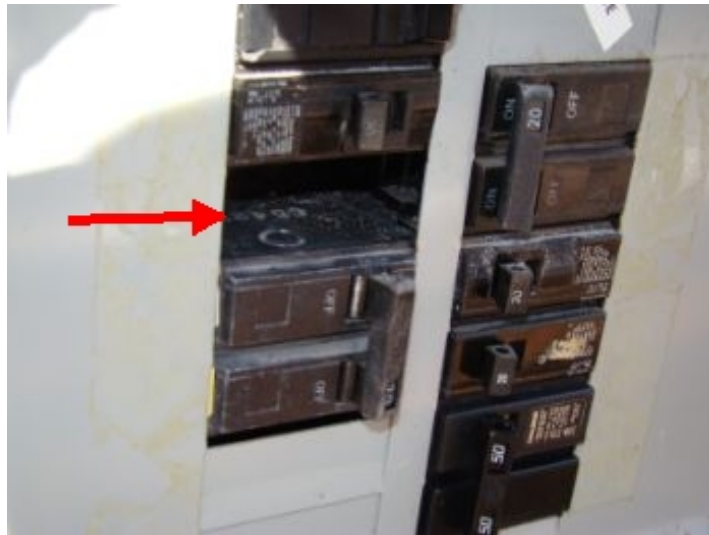
## 1. Electrical Panel

- No major system safety or function concerns noted at time of inspection at main panel box.
- Knockouts need snap-in caps inside panel box. Should be installed to keep mice out of panel box and to avoid potential electrocution hazard.

Page 15 Item: 1	Electrical Panel	<ul style="list-style-type: none"> <li>• Knockouts need snap-in caps inside panel box. Should be installed to keep mice out of panel box and to avoid potential electrocution hazard.</li> </ul>
-----------------	------------------	--

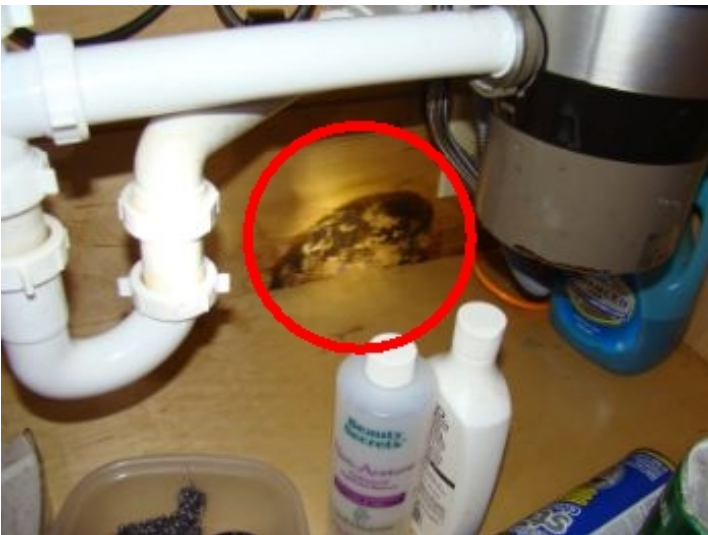
- Appeared functional and in satisfactory condition, at time of inspection.
- There appears to be water damage under sink. This tested dry at the time of the inspection, but monitor for any further intrusion.

Page 27 Item: 1	Cabinets	<ul style="list-style-type: none"> <li>• There appears to be water damage under sink. This tested dry at the time of the inspection, but monitor for any further intrusion.</li> </ul>
Page 27 Item: 3	Dishwasher	<ul style="list-style-type: none"> <li>• The dishwasher did not operate when tested, consult with the seller about servicing the unit.</li> </ul>
Page 28 Item: 8	Sinks	<ul style="list-style-type: none"> <li>• Stains from presumed past leaks noted.</li> </ul>

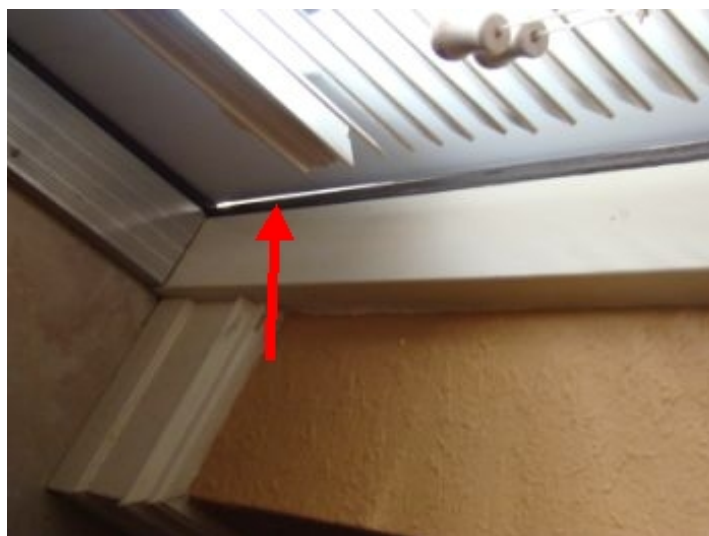
Observations:  
• Air and light entering at porch entrance door.

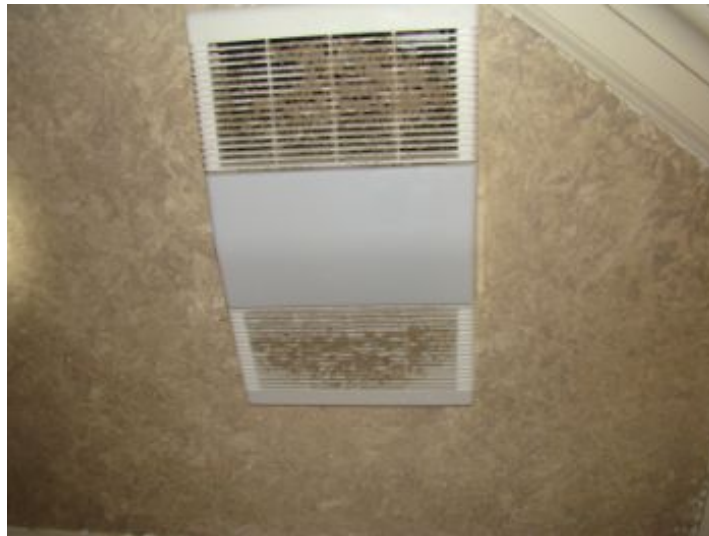
Bathroom Exhaust Fan

- Needs to be clean out .

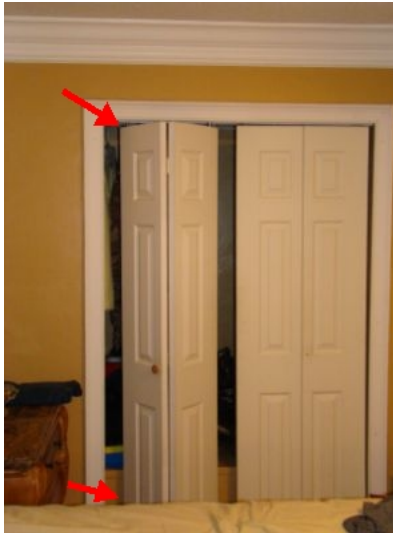
- The closet door has fallen out of square and drags on the floor. We recommend contacting a qualified contractor to realign the door.

Page 34 Item: 2	Closets	<ul style="list-style-type: none"><li>• The closet door has fallen out of square and drags on the floor. We recommend contacting a qualified contractor to realign the door.</li></ul>
Page 35 Item: 4	Electrical	<ul style="list-style-type: none"><li>• Missing switch plate covers were found, make sure they are replaced.</li><li>• Outlet cover plates missing.</li></ul>
Page 35 Item: 6	Smoke Detectors	<ul style="list-style-type: none"><li>• There were no smoke detectors present in the bedroom(s).</li><li>• No smoke/ fire detectors were installed at time of inspection.</li></ul>

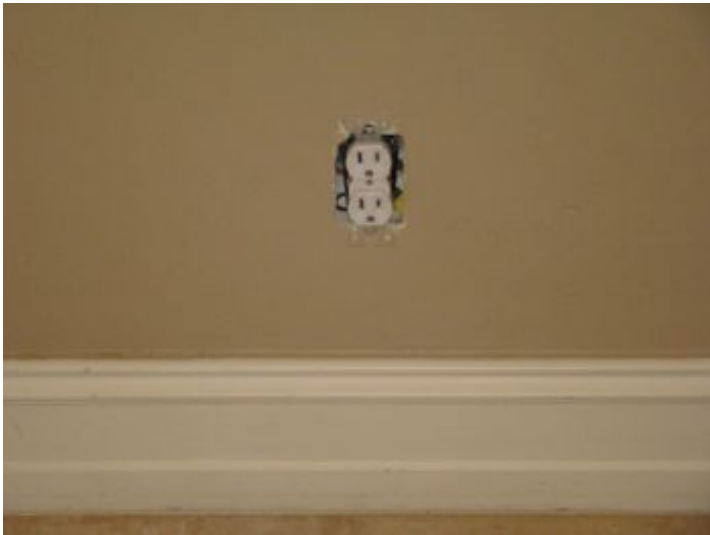
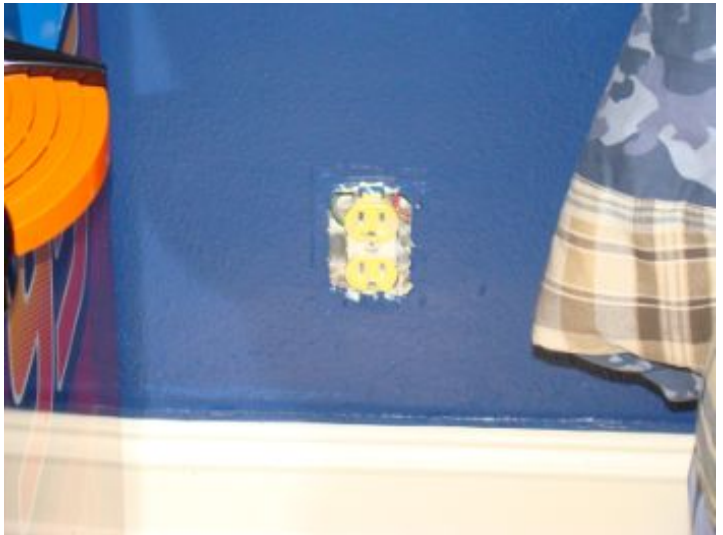
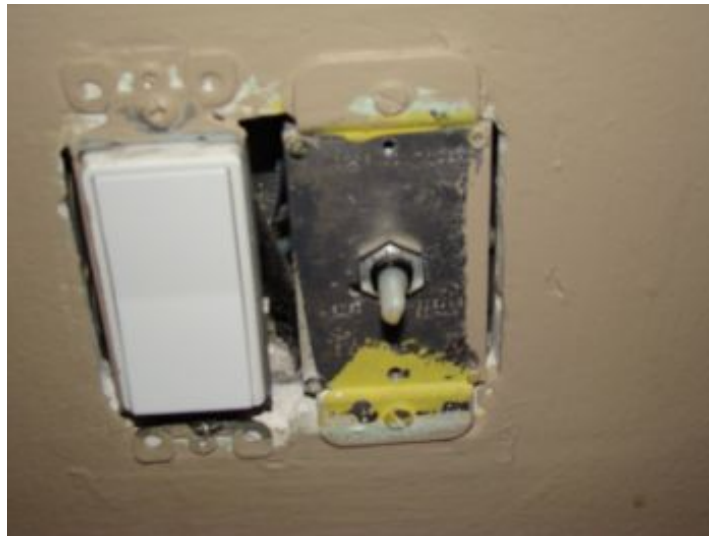
- Have a qualified electrician repair items listed following a complete evaluation of the electrical system.
- Missing switch plate covers were found, make sure they are replaced.
- Outlet cover plates missing.
